Coastal Morphology Report

Essex (part sub-cell 8 Harwich to Canvey Island)

RP044/E/2015
March 2015

Coastal Trends Analysis

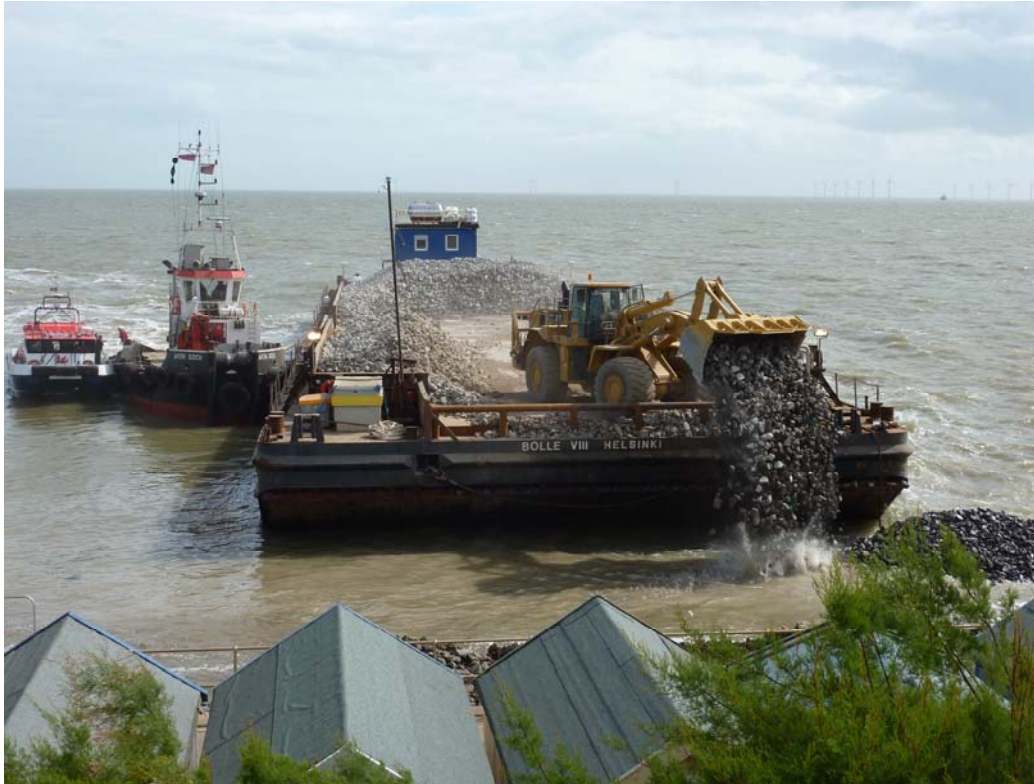
Barge anchored close inshore and being unloaded on to the beach. Photo courtesy of Mike Badger – Tendring District Council.

There has been extensive works on the Clacton frontage, which commenced after the latest data used in this report. The scheme is made up of 23 fishtail rock groynes and approximately 950,000 cubic metres of sand and shingle beach recharge.

The works will be undertaken in two phases; the first phase of works is from Holland Haven to Cliff Road, Holland on Sea and the second phase will be from Cliff Road to Clacton Pier. The works are proposed to be completed by late autumn 2015. *See photos below.*

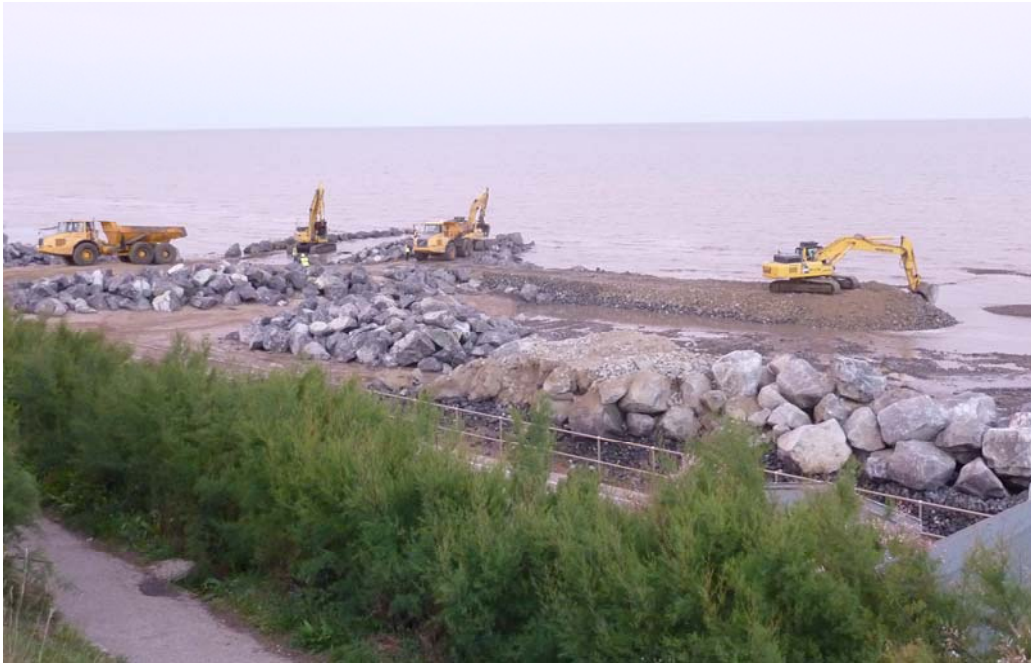
Material being placed and graded as required. Photo courtesy of Mike Badger – Tendring District Council.

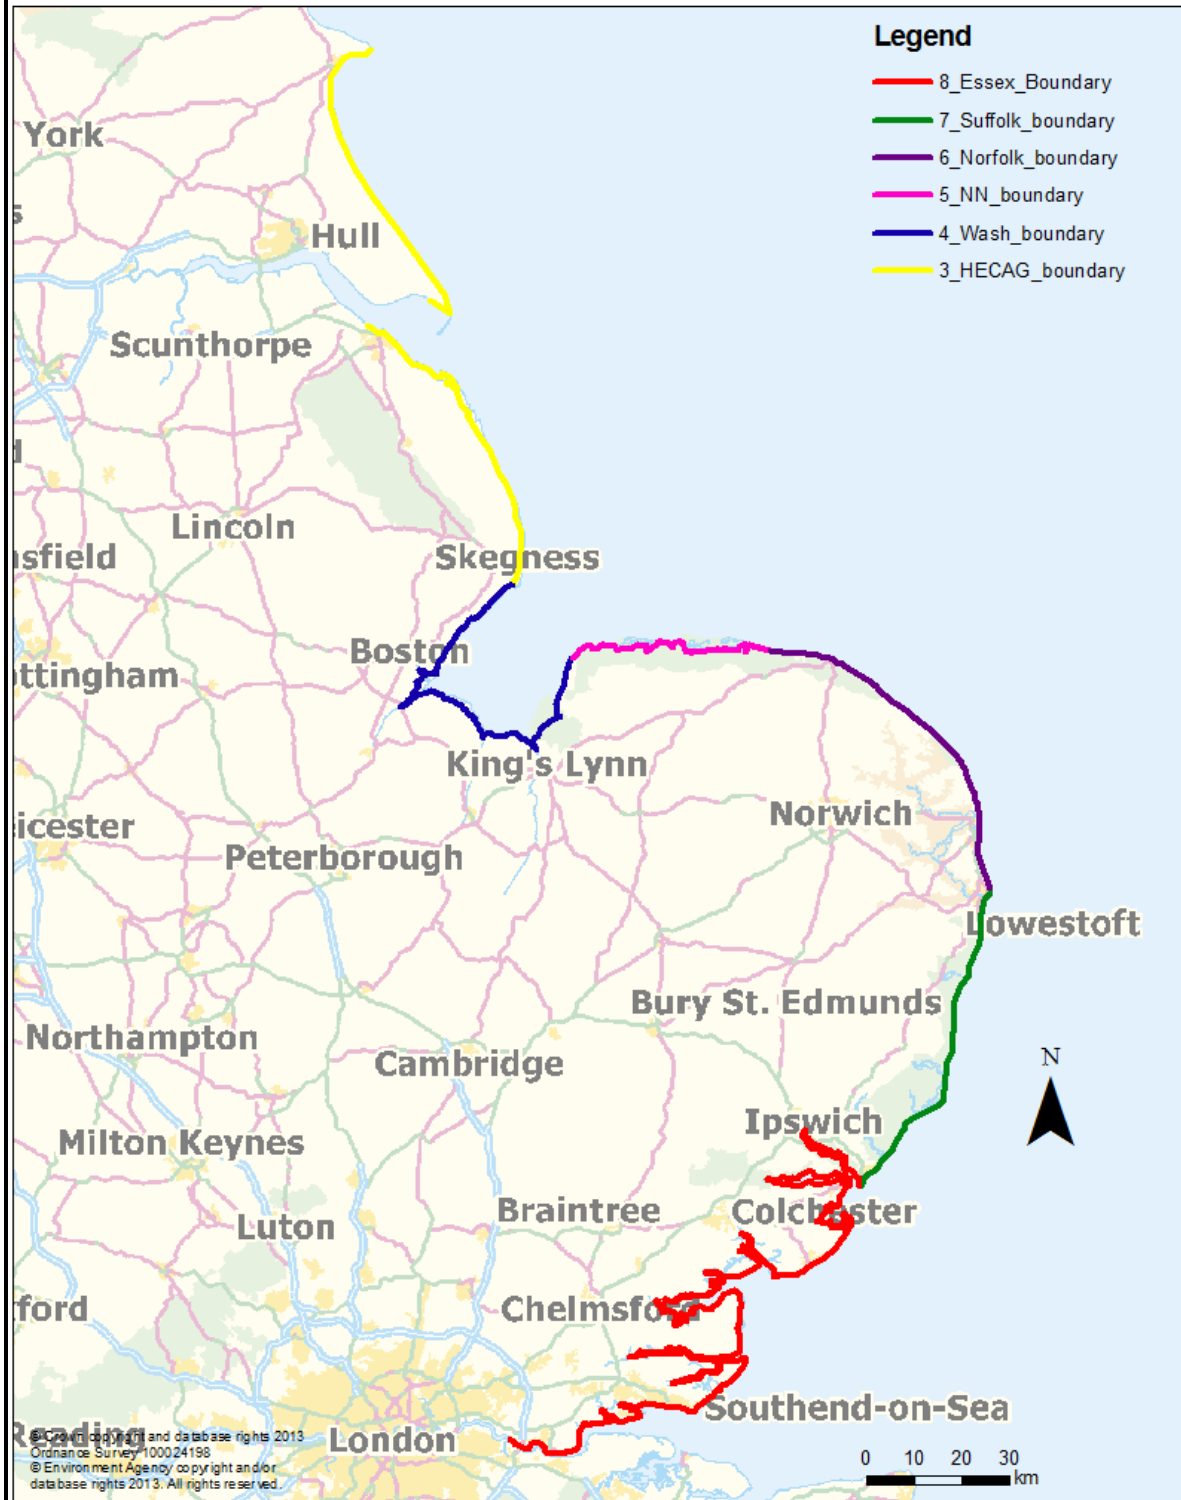
Map 1 - SMP Boundaries

The Environment Agency (EA) has carried out a programme of annual strategic monitoring of the Anglian coast since 1991, namely Anglian Coastal Monitoring Programme (ACMP). The rationale behind the programme is to assist the implementation of appropriate and sustainable works on the coast, whether undertaken by the EA for the purpose of flood risk management or by various maritime district council partners for coastal protection. An additional output from the monitoring programme is the assessment of coastal dynamics to inform long term strategies for the coastline. The platform for this is the Shoreline Management Plan (SMP) process, which sets out coastal strategies for future epochs, based on evidence from monitoring programmes. *Map 1* (below) shows the SMP boundaries for the Anglian coast.

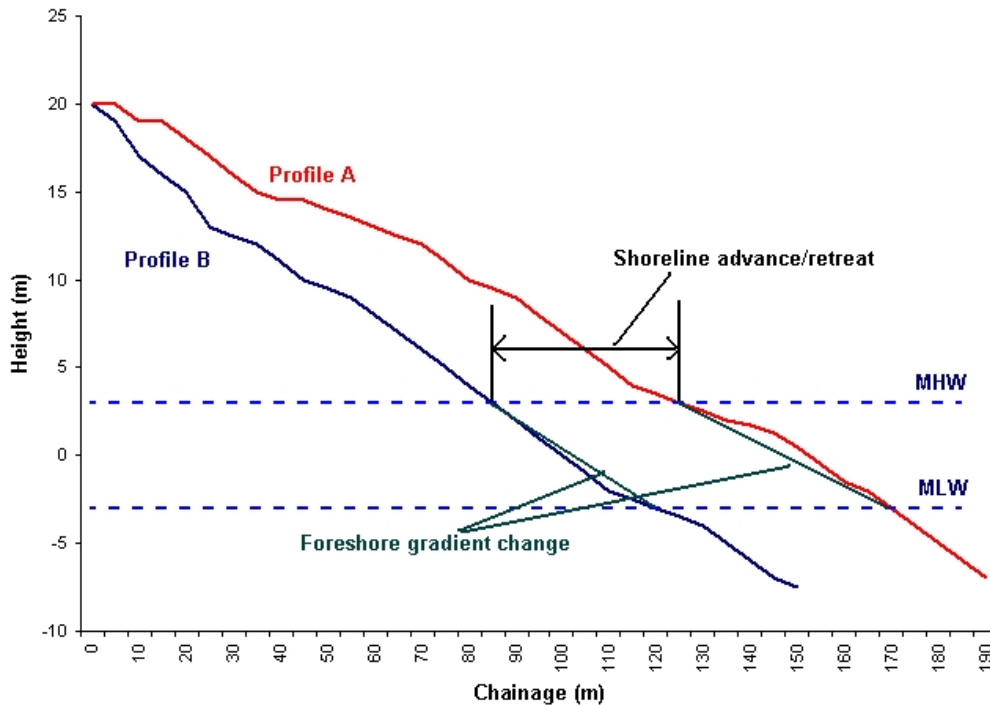
Figure 1 (below) demonstrates the principle of beach profile change over time along with changes to beach gradient. Along certain stretches of coast where seawalls or other structures constrain the landward movement of the coast, beach volumetric change may be of interest. This is particularly relevant where artificial beach nourishment is undertaken. In other areas, where long frontages are unconstrained by linear defences, the quantification of beach volumetric change is of less importance.

Figure 1 – Conceptual diagram of a beach profile showing shoreline advance/retreat and foreshore change parameter

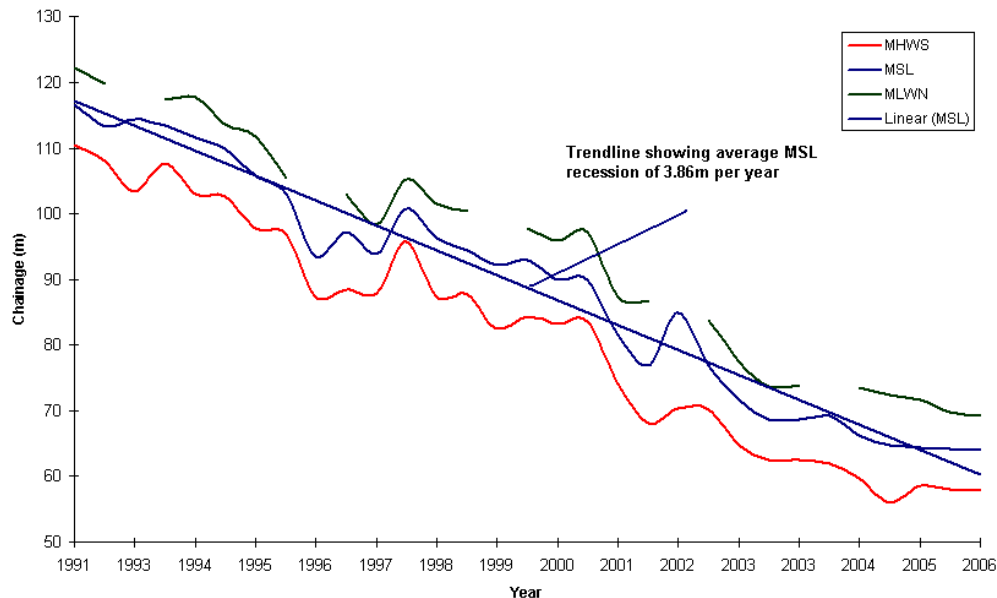
Figure 2 (below) demonstrates how the analysis was performed and a trend is obtained. The example used in Figure 2 is from an eroding beach, which is retreating with an average trend of -3.86m/yr. However, in any single year the actual erosion observed varies considerably. For example between 1996 and 2000 very little erosion occurred, whereas between 2000 and 2001 the beach retreated by almost 20m. Therefore the analyses indicated in this report relate to longer term general trends and cannot be used to determine short-term erosion or accretion rates.

Figure 2 – Suite of coastal profiles after SANDS beach level analysis with linear regression of MSL giving annual trend (data gaps are due to certain profiles not extending down to MLW level)

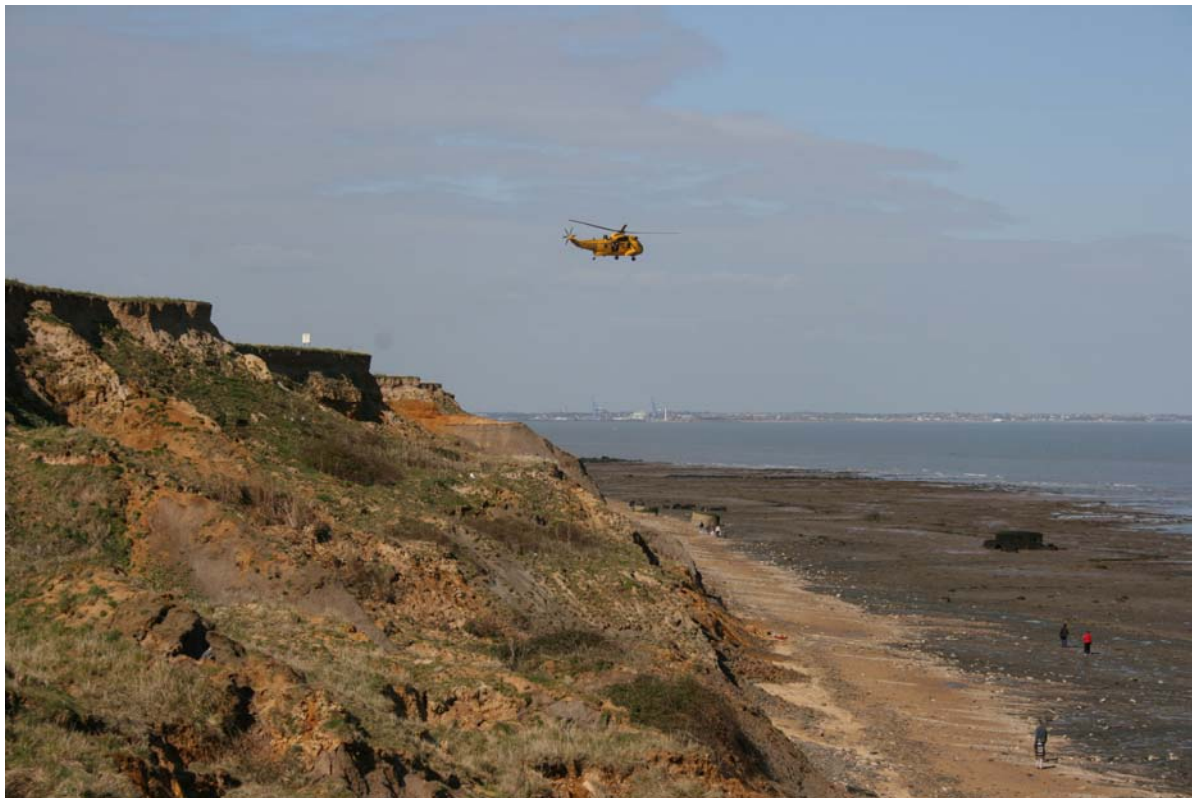
Slightly lower erosion trends of cliff recession than the rest of the Naze and lower erosion trend at MLWN compared to MSL and MHWN. The base of the cliff has retreated by approx 35m in the period 1992 to 2014. Flattening profile.

Cliff slumping at the Naze.

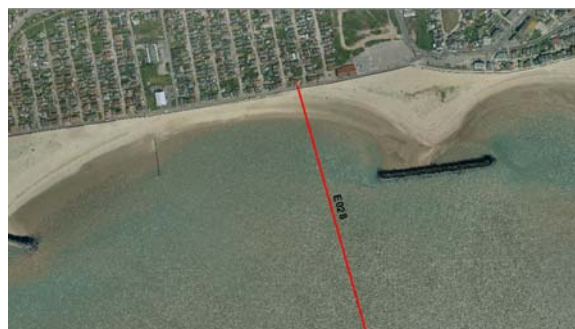
Before Breakwater construction

Trends for this profile have been calculated from 1999 when an additional fishtail breakwater, a shore parallel breakwater and arm extensions to an existing fishtail breakwater were constructed. These additions, along with beach recharge, took place as part of the West Clacton to Jaywick Sea Defences. This was in addition to the original scheme of 1986 to 1988 when four fishtail breakwaters were constructed together with beach recharge. Pre-1999 trends showed significant erosion trend. Post 1999 trends show a similar story with significant erosion event in 1999/2000 followed by steady erosion until the end of 2008 when an additional shore-parallel rock groyne was constructed on the line of the profile. Since 2009 the profile has remained stable.

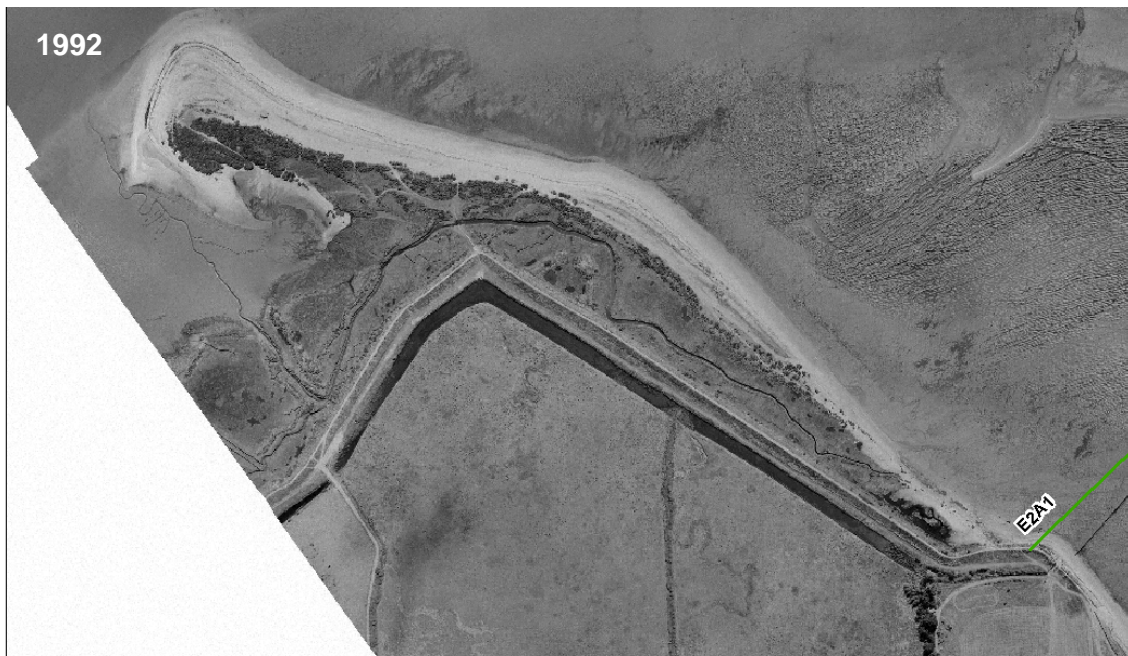
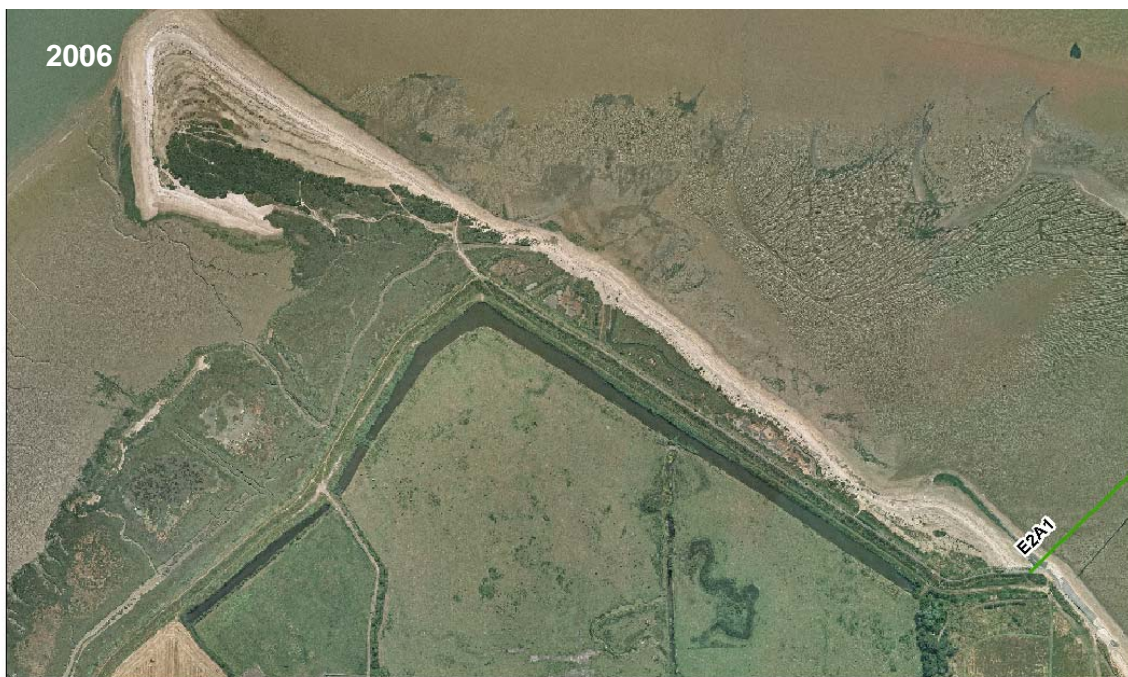
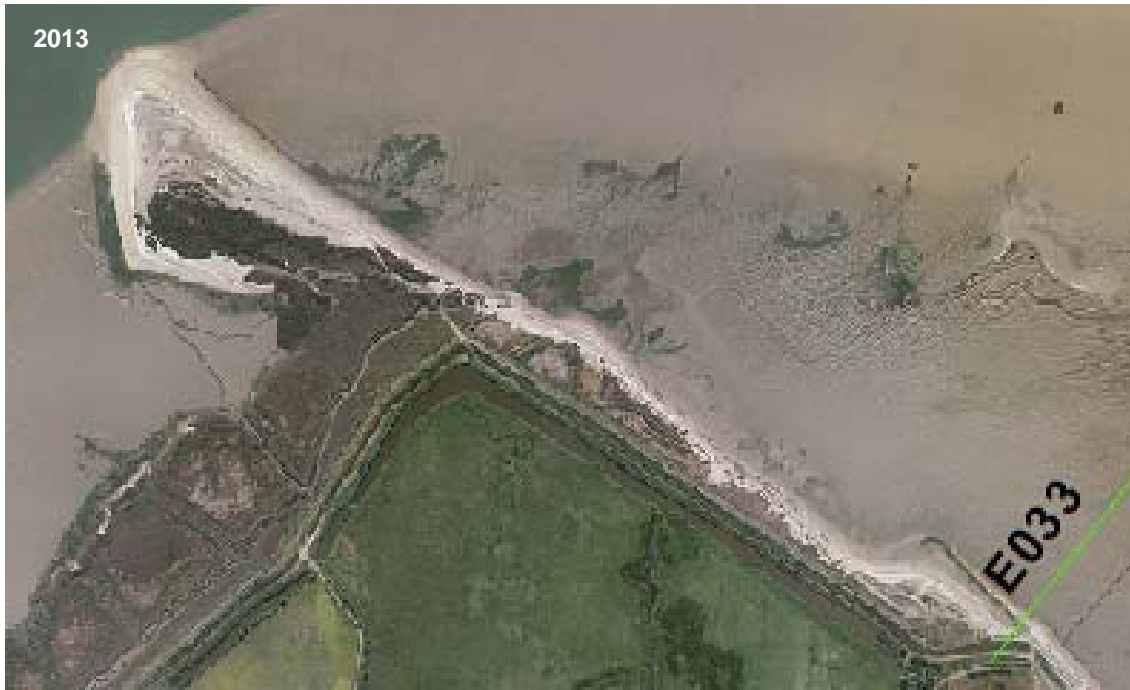
estuary. Between 1992 and 2013 the base of the spit has accreted north of the profile by c40m, erosion mid-way c25m and a width accretion at the end of the spit by c17m. Immediately adjacent to the northeast of the profile a headland has established between 1992 - 2013 (see below) extending c120m and an extended width of c40m.

Accretion immediately north of E033 (E2A1) and at distal end of spit with erosion midway along spit from 1992 - 2013

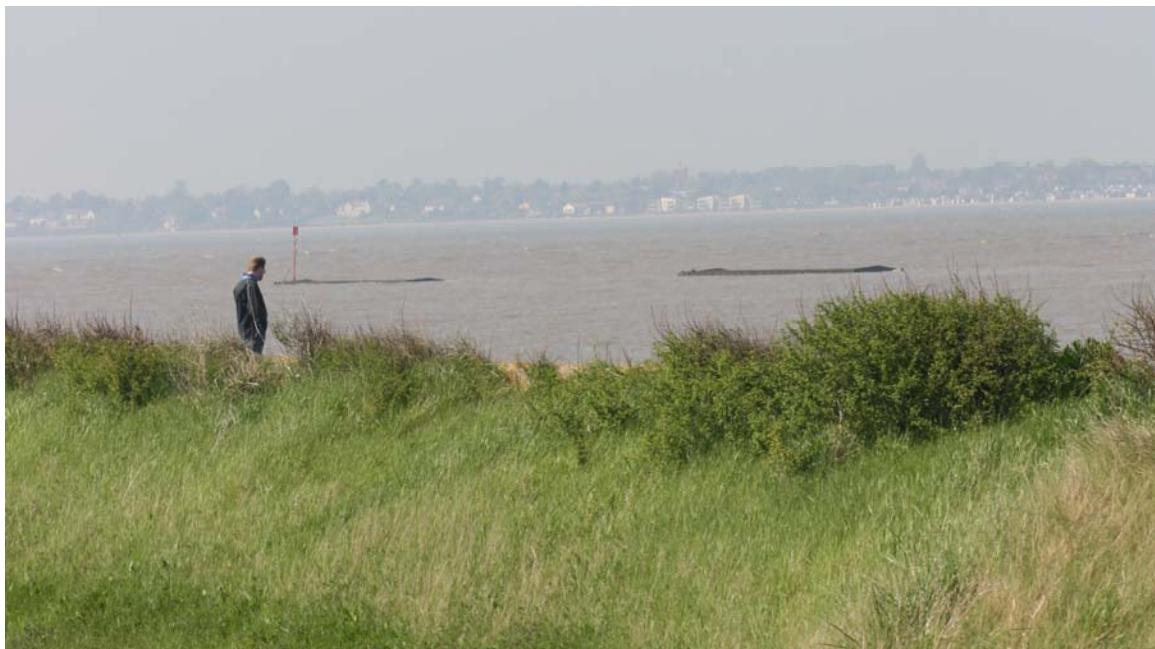
Lighter barges (see photo below) placed on profile in late 1980s at 240m chainage. There has been a steady build up of mud landward side of the lighter barges since their installation. No movement at MHWS due to sea defence. No movement at MHWN due to lighter barge. Slight erosion trend at MSL but is adjacent lighter barge. Slight accretion at MLWN. No rotation

Lighter barges with embankment in the foreground

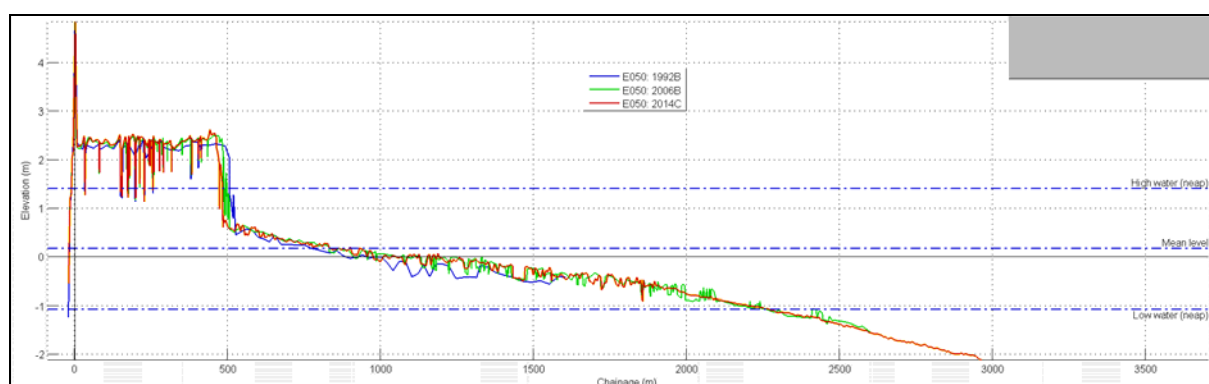
Saltmarsh at MHWS. Moderate erosion trend at MHWN. Significant accretion trends at MSL and MLWN. Very slightly flattening profile.
