**Essex Coastal SSSIs:
Assessment of Changes in Extent of
Saltmarsh Over the Period 1997 to 2008**

Report to Natural England

8th June 2011

Report: ZBB745-F-2011

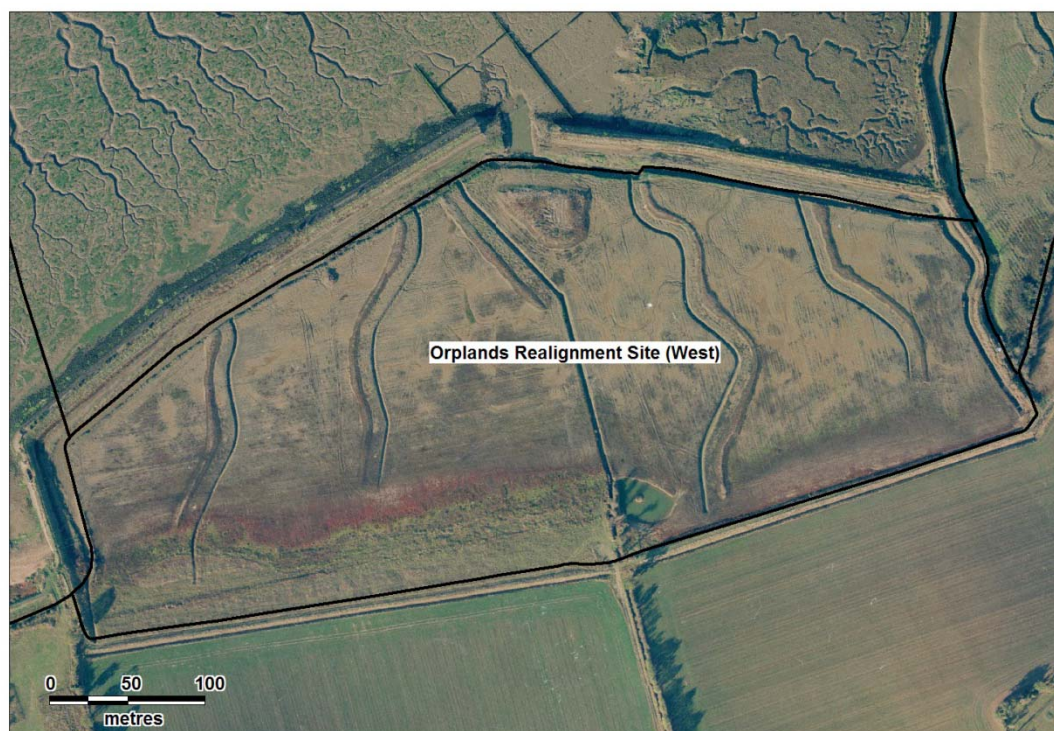
Plate 1: Orplands Realignment Site (West), 1997.

The western section of the Orplands realignment site does not lie within the Blackwater SSSI but has been considered here because, although separate from the eastern realignment, it is contiguous with it (Map 30). This section was also breached in 1995. Although some early pioneer saltmarsh colonisation was present in 1997 (Plate 1), saltmarsh had not developed sufficiently to allow mapping in the baseline year. By 2008 the saltmarsh had colonised and an area of 10.77ha was recorded.

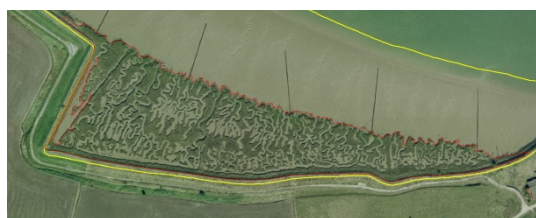
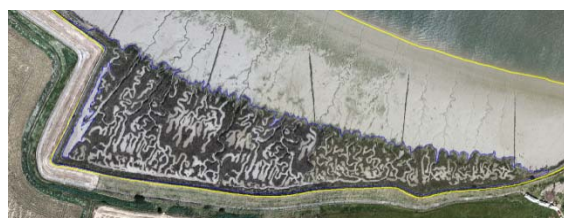
Plate 2: Complex creek system in Unit 37

Saltmarsh in this unit is present on the south bank of the River Crouch to the south of Bridgemarsh Island, below Raypits Reach (Map 62). A net loss of 0.24ha was recorded for this unit during the study period. The main body of the marsh has a complex creek system which was not digitised in detail but it can be seen from the photographs below that it has remained fairly stable over the survey period.

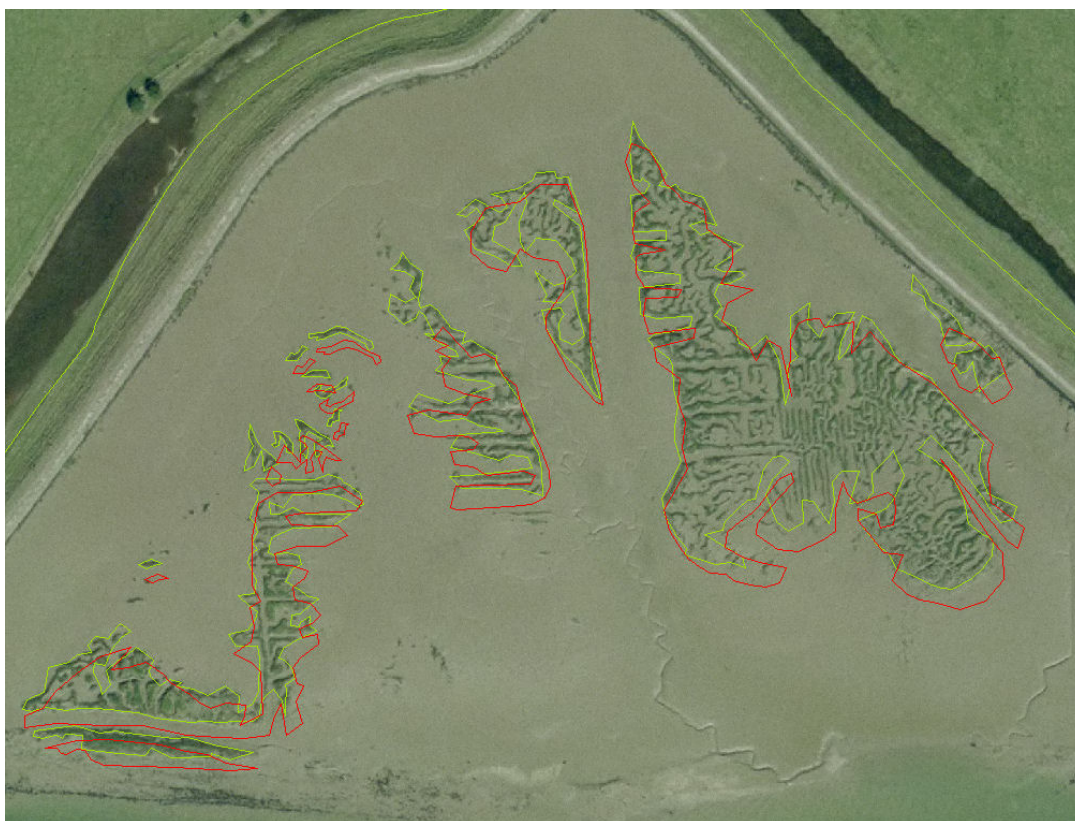
Plate 3 – Variable orthorectification between baseline and comparison years

For example, some of the aerial photographs for the Crouch and Roach displayed a slight shift of between 3 and 6.5m to the Ordnance survey reference and the SSSI boundaries based upon it (Plate 3). Although this did not affect the total extent of saltmarsh calculated in each year, the areas of net accretion and erosion between the baseline and comparative years have been significantly skewed. Due to the nature of orthorectification, these discrepancies are not uniform and therefore cannot be easily accounted for or corrected.

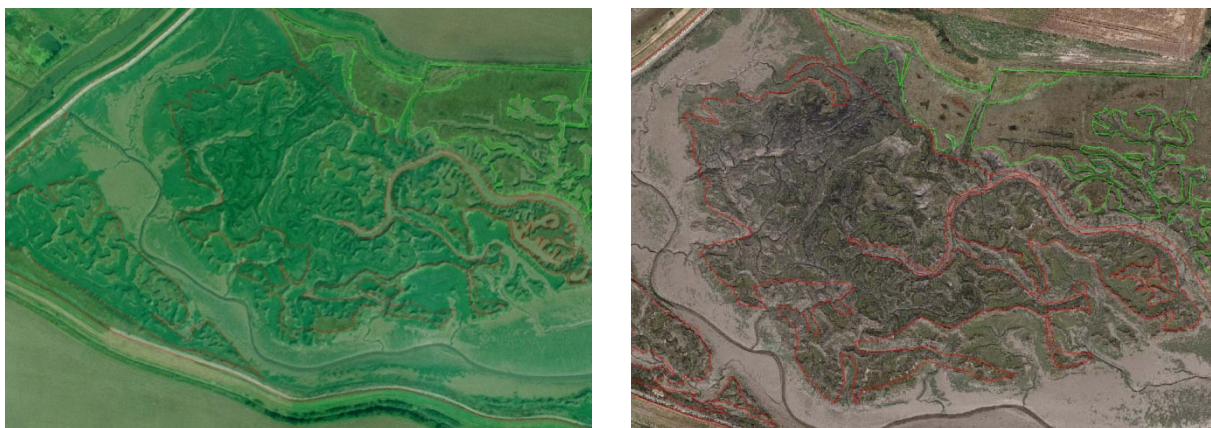
Plate 4 Differences in atmospheric haze, photograph resolution and colour saturation.

The brightness and colour balance varied slightly between some of the aerials – the boundaries between saltmarsh and other vegetation such as green algae (*Enteromorpha* sp) were more difficult to differentiate in the darker photographs as subtle colour differences and textures were less evident (Plate 4). Aerials between years also varied in clarity due to either atmospheric haze or photograph resolution (Plate 4).

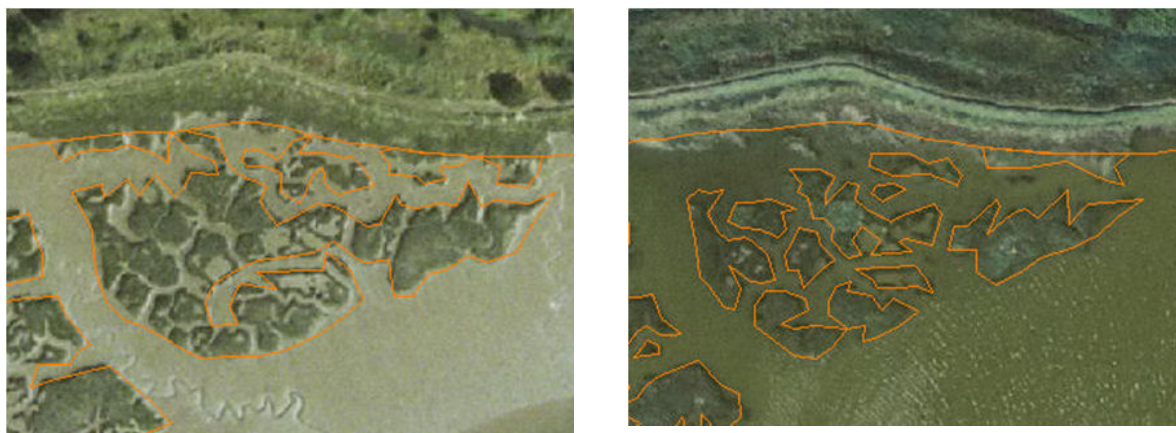
Plate 5 Further fragmentation of saltmarsh between years leads to differences in mapping technique and subsequent area/extent calculated

Finally, fragmentation of some areas of saltmarsh which were previously mapped as one polygon in one year has led to the decrease in extent by the comparison year. An example of this can be seen in Plate 5 where the area was digitised as one polygon in a baseline year, as the individual saltmarsh patches were too close together for individual polygons. However by the comparative year, the saltmarsh patches had further eroded, becoming more fragmented, with wider creeks, requiring the digitisation of the individual fragments. In cases such as these, under this method, the losses calculated are often larger than are actually the case.
